August 30, 2018

This report has been generated to forward snow and ice expert observations, conclusions, and opinions related to a slip and fall incident that occurred February 13, 2016 in the U-Park parking lot adjacent to the Old Mattress Factory in Omaha, NE. These observations, conclusions, and opinions have been developed by reviewing case documents in the Tonia Ackerman and Dennis Ackerman v. U-Park, Inc. case. The case is filed in the United States District Court for Nebraska. Case number: 8:17-CV-209.

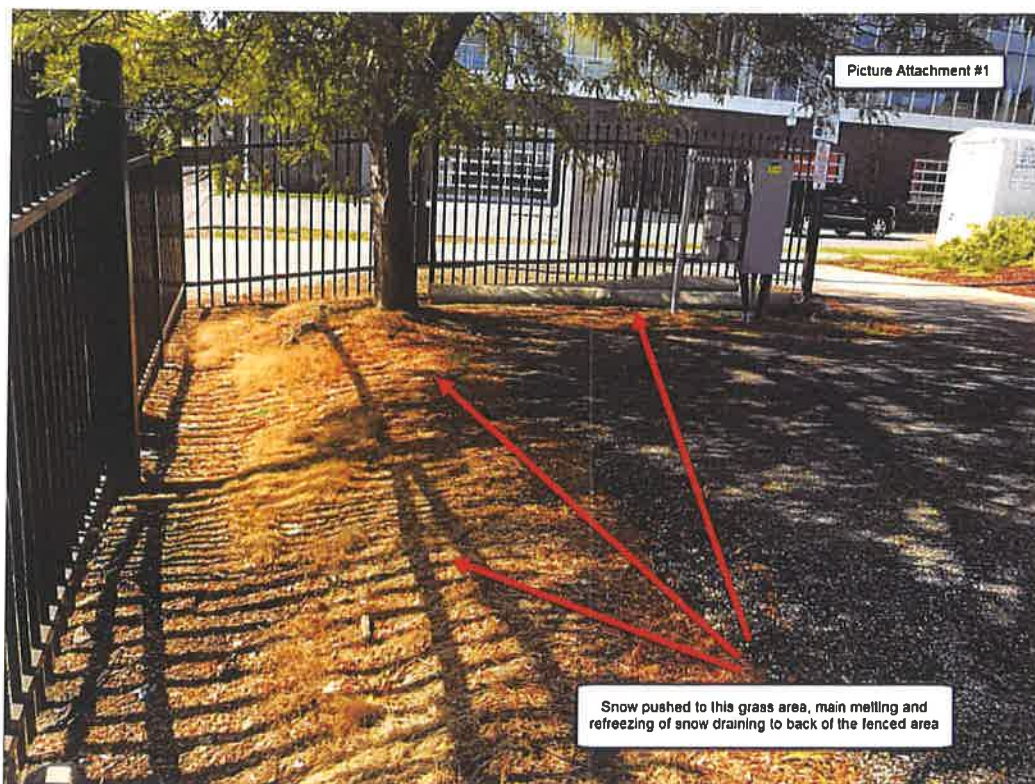
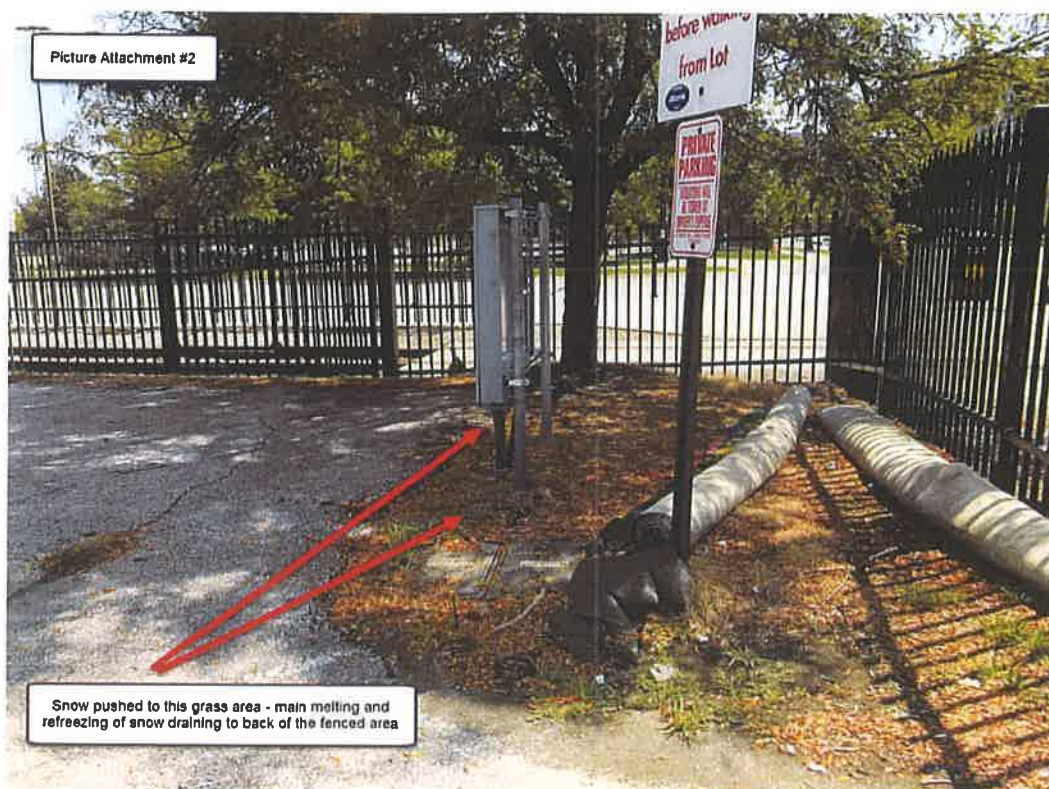
8. *A site visit was conducted by Jeremy Swenson on August 16, 2018 to examine the area of the slip and fall incident, and the drainage of the parking lot of the slip and fall area in relationship to the snow that had been plowed by the defendant, and placed on the perimeter of the property, as shown in the case photo, exhibit #5. The intention of the site visit was to focus on the slip and fall incident area, and the potential drainage issues that may have come from melting and refreezing of snow, and to examine the slip and fall area for potential “bird baths” in the parking lot area where the slip and fall occurred. (Jeremy Swenson site visit – August 16, 2018). Picture attachments #1 and #2 show two of the main areas in relation to the slip and fall incident where the defendant states that the snow was pushed when snow plowing the U-Park, Inc. parking lot in the winter months. The snow (as shown in the photo in exhibit 5), was pushed to the grassy areas of the edge of the parking lot, and the snow melted and drained towards the fence as shown in Picture attachment #1 and Picture attachment #2.*

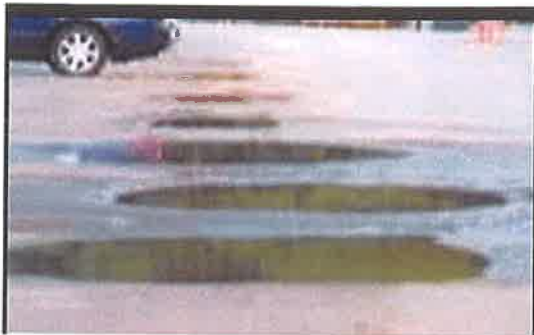
Mr. Wayne states in his report that from his site visit he believes there is a “birdbath” behind parking space #153. I disagree with his conclusion. I do agree that there is a water drainage path that runs towards and through this area, but in my opinion it is the path of a normal drainage area in the parking lot, and not the result of the defendant’s poor parking lot maintenance. I have seen hundreds of “birdbaths” in parking lot areas and have included a picture of what they look like in parking lots. They include deep depressions in asphalt that are usually round or oval shaped, holding water for many days in parking lots, hence the name “birdbath”.

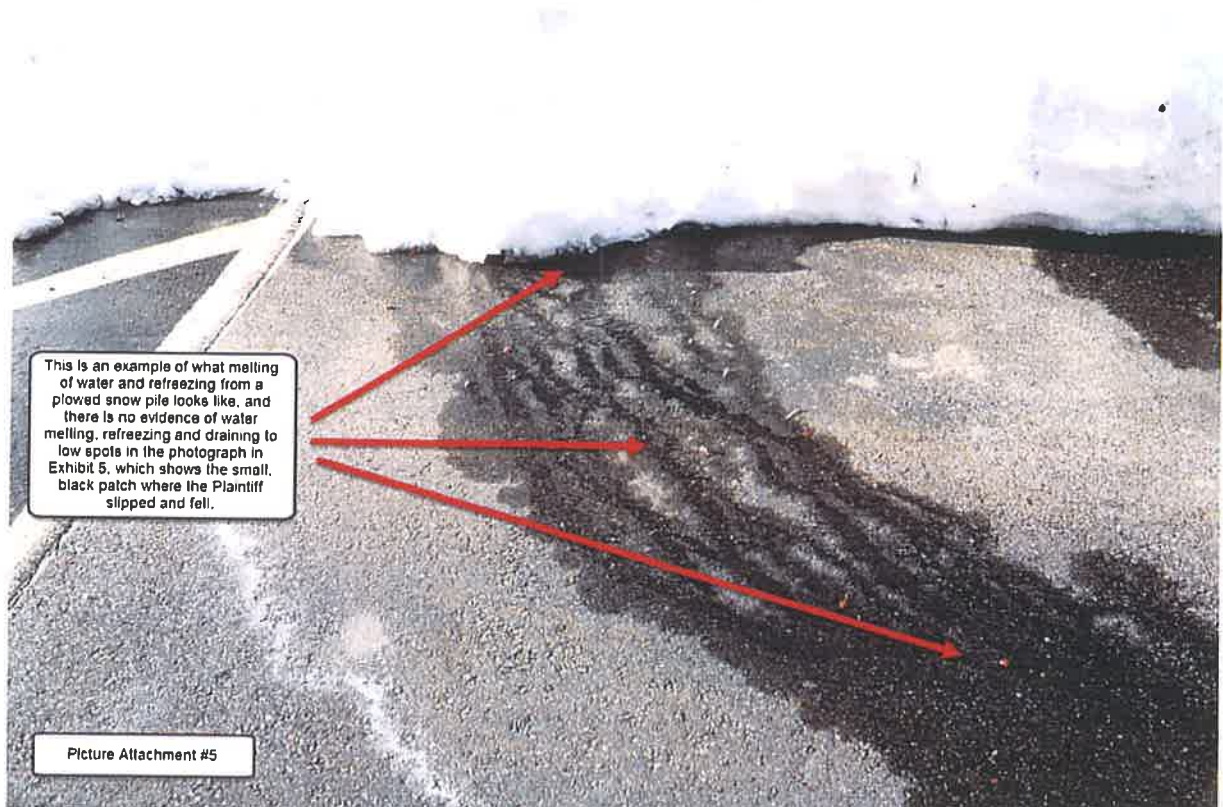
Melting and refreezing of snow is very easy to spot in a parking lot 6 days after a winter storm because the majority of the parking is usually bare pavement, but the area where snow has melted is very obvious because there are black marks or streaks that have leaked out or run across the parking lot, and then the water running across this area refreezes when temperatures drop below freezing, creating slick conditions. I have included Picture attachment #5, which shows an example of what melting and refreezing of snow looks like coming from a pile of snow. There is no evidence of any melting and refreezing from snow piles of the U-Park, Inc. parking lot the day of the slip and fall incident. It is my opinion that U-Park, Inc. had successfully inspected and remediated any threat from melting and refreezing of snow from snow piles on February 13, 2016.
